Manhole Inspection Summary

Manhole # S33I__003MH

Insp Date: **1/13/09 11:21 AM**

Location Address: **31 w lombard st**

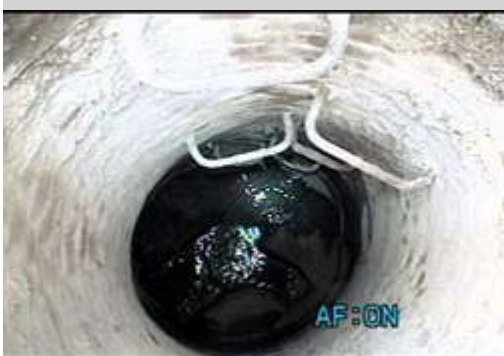
Defect 1

Count: **8** Missing: **2** ☒ **Corroded**

steps corroded and missing

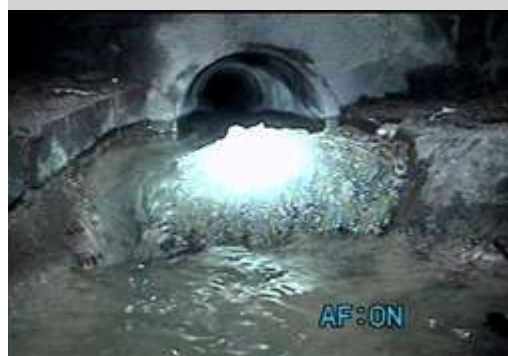
Defect 2

Condition: ☐ Sound ☐ Cracked ☐ Root Intrusion ☐ Deteriorated ☐ Leaks ☒ **Debris**

channel debris

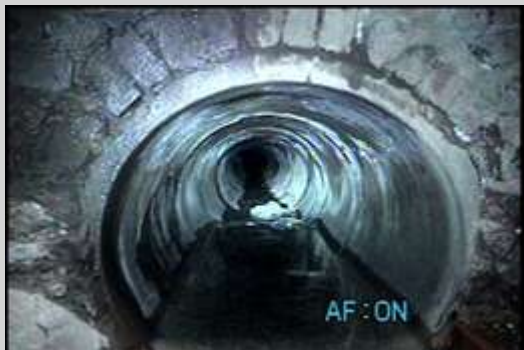
12 O'Clock Outflow

21 in. Circular Gravity Sewer
Pipe Out @ 12 O'Clock

Pipe Material: **Clay** ☐ Pipe Lined

Invert Depth: **13.41** (ft.) Flow Characteristics: **Fast**

Deposits: ☒ None ☐ Mud ☐ Sludge ☐ Debris ☐ Grease

Infiltration: **None** Pipe Seal Cond: **Unknown**

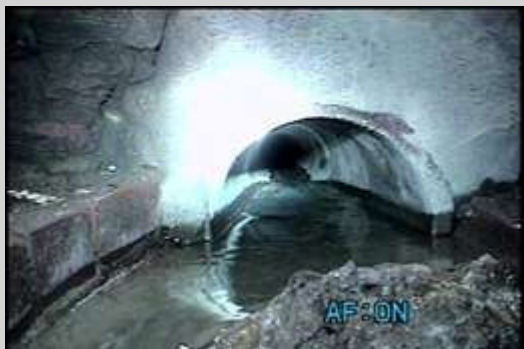
6 O'Clock Inflow

10 in. Circular Gravity Sewer
Pipe In @ 6 O'Clock

Pipe Material: **Clay** ☐ Pipe Lined

Invert Depth: **13.10** (ft.) Flow Characteristics: **Fast**

Deposits: ☒ None ☐ Mud ☐ Sludge ☐ Debris ☐ Grease

Infiltration: **None** Pipe Seal Cond: **Unknown**

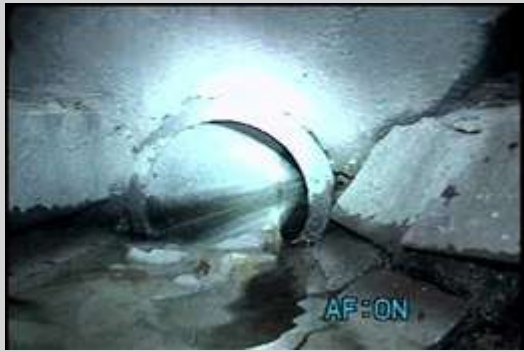
9 O'Clock Inflow

8 in. Circular Gravity Sewer
Pipe In @ 9 O'Clock

Pipe Material: **Clay** ☐ Pipe Lined

Invert Depth: **13.13** (ft.) Flow Characteristics: **None**

Deposits: ☒ None ☐ Mud ☐ Sludge ☐ Debris ☐ Grease

Infiltration: **None**
